TEST REPORT

TV11968-001-01

BOTTOM PLATE ANCHOR TESTING FOR MAXRAFT

MBSS, trading as MAXRaft
PO Box 2606
Queenstown
New Zealand

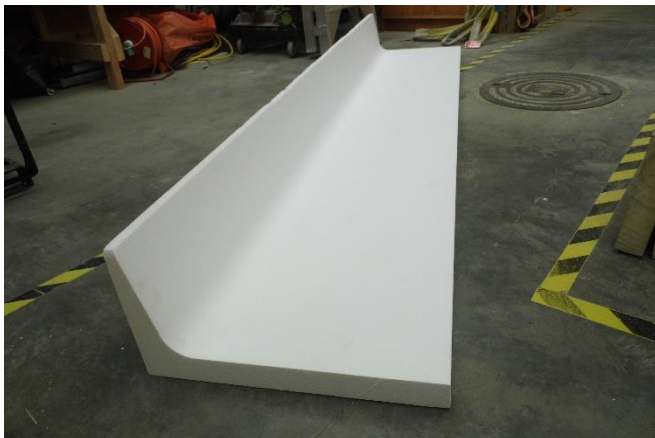
MAXRaft polystyrene edge forms were supplied to BRANZ by the client for testing. These were 2400 mm long, 495 mm wide and 250 mm high, with a tapered edge approximately 20 mm thick at its narrowest. Plain edge forms and corner sections (600 x 600) were supplied (see Photograph 1).

Photograph 1. MAXRaft edge form as supplied

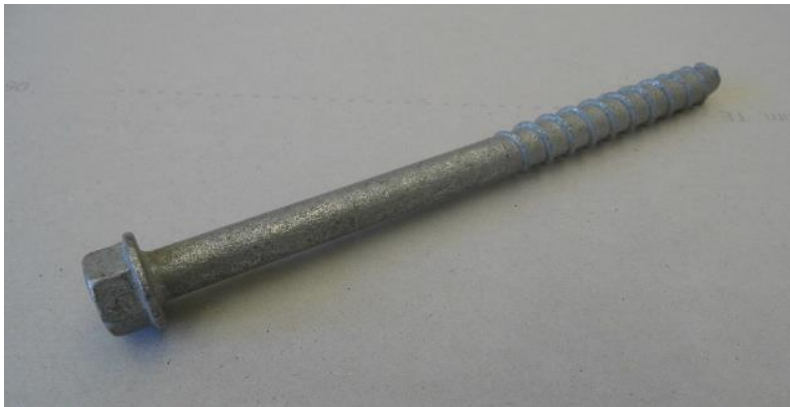
The bottom plate fastener supplied by the client was a Simpson StrongTie THD10160MG screw anchor (see Photograph 2). Measured length was 160 mm underneath the head (75 thread length). Shank diameter was 9.9 mm for the unthreaded shank and 9.65 mm for the threaded shank. Outer diameter over the threads was 12.25 mm.

Photograph 2. Screw anchor (Simpson StrongTie THD10160MG)

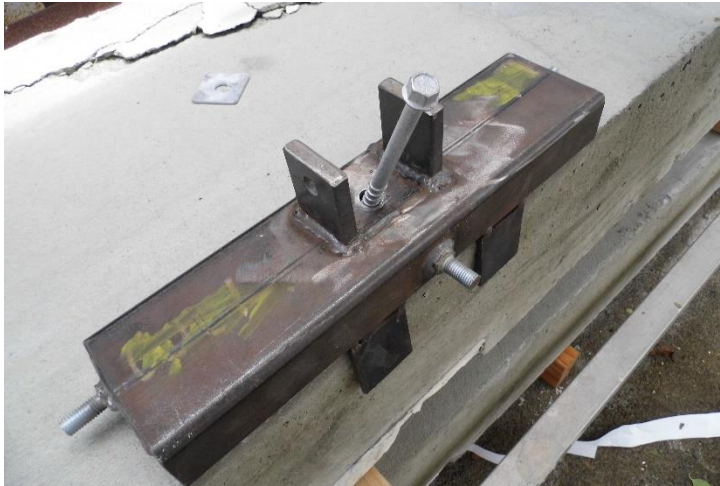
The anchors were installed into pilot holes in the concrete, drilled using a jig supplied by the client to ensure the drill angle was 11° from vertical (see Photograph 3).

Photograph 3. Jig used for drilling pilot hole for anchor.

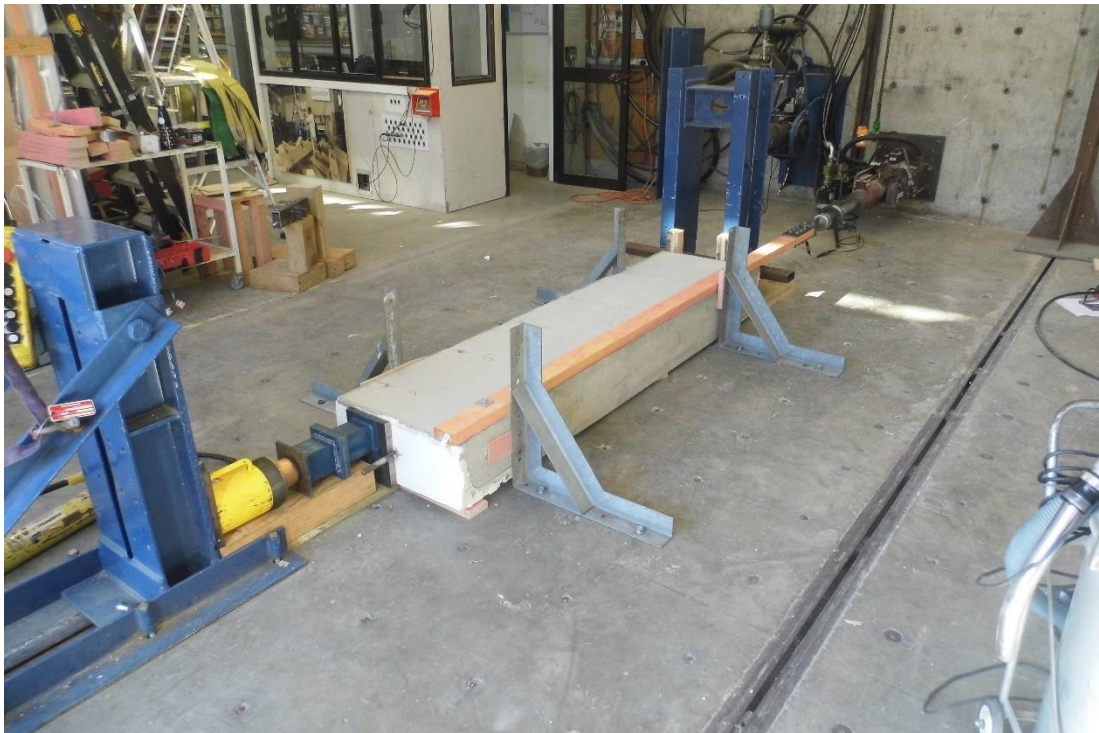
Photograph 4. Set-up for in-plane tests

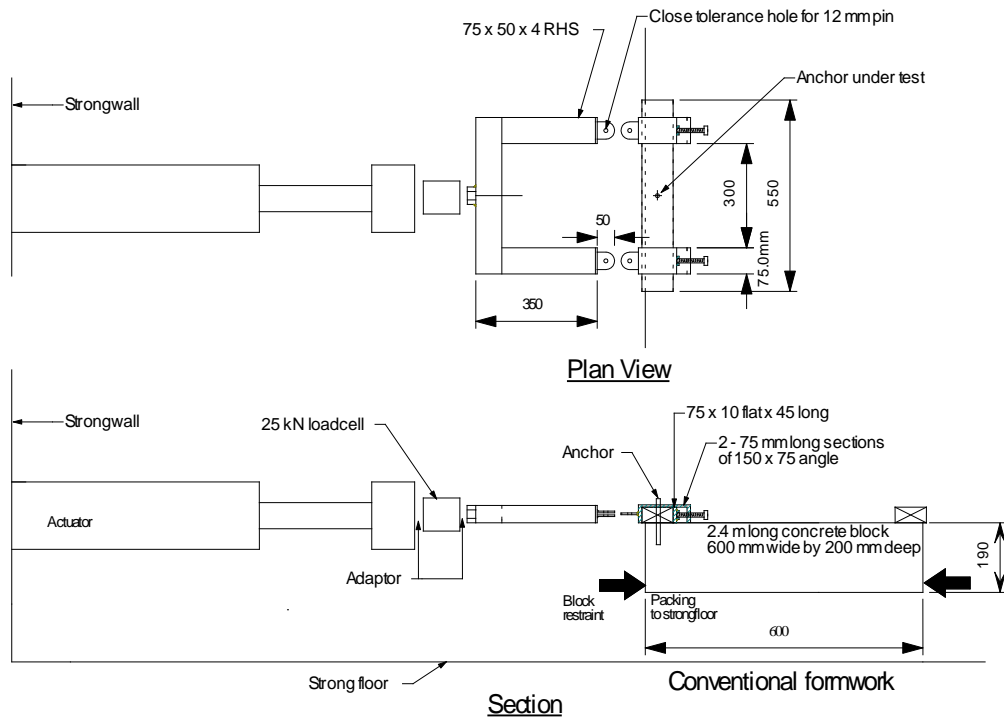
Figure 3. Test set-up for out-of-plane loading perpendicular to bottom plate

For the out-of-plane shear tests, the load was applied to the timber plate at points centred 188 mm on either side of the anchor. For the in-plane load tests, the end distance to the anchor was a minimum of 150 mm. For the initial tension tests on bottom plate anchors, the load was applied to the plate via two steel fixtures spaced 108 mm on either side of the anchor.

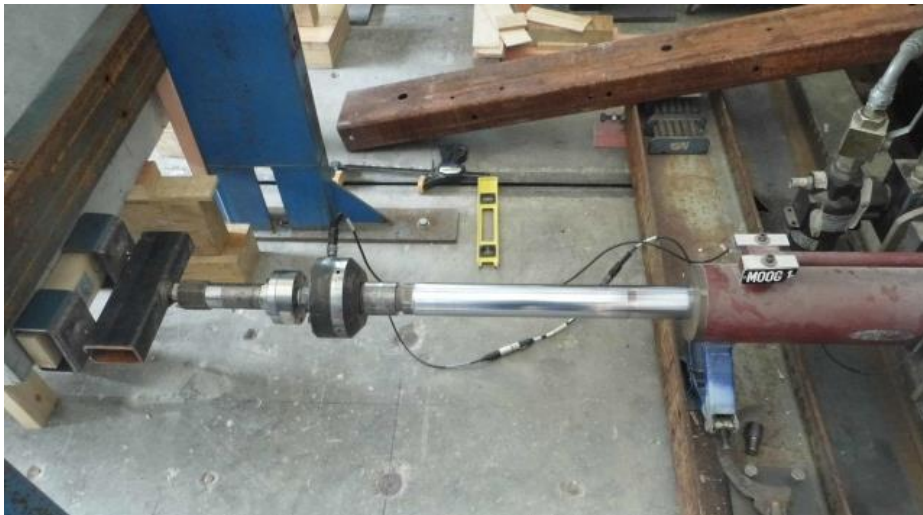
Photograph 6. Test set-up for axial tension loading (bottom plate anchors)

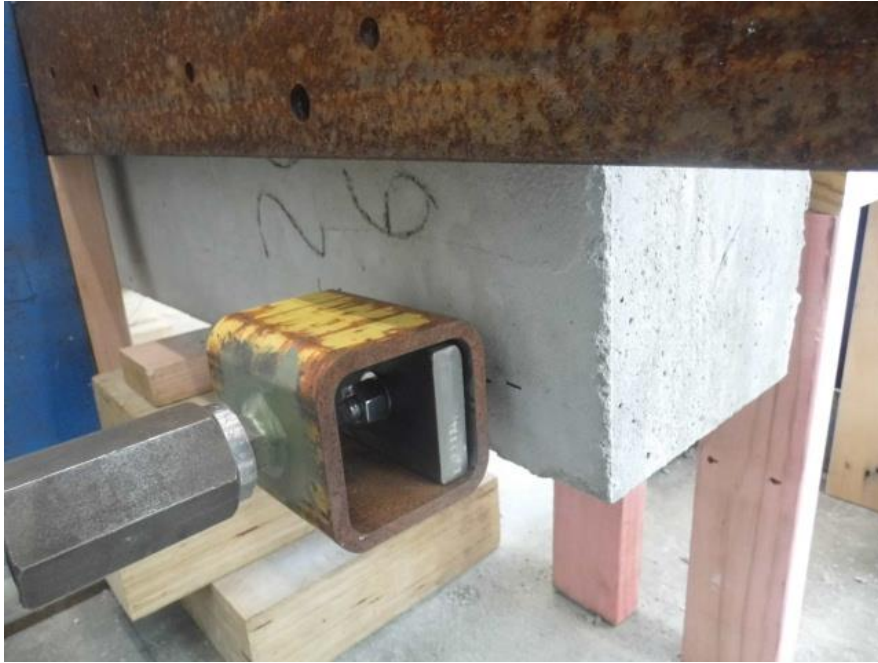
Photograph 7. Steel fitting used for axial tension tests (without bottom plate)

The bolts were screwed into the concrete and tightened over the timber used for the bottom plates with a spanner until they were just snug tight against the plate. For the direct tension tests, the bottom plate was substituted with a steel fixture to avoid timber plate breakage, see Photograph 7.

Early tension tests on the bracing hold-down anchors caused the bottom plate to fail in flexure and so the timber was replaced with a direct application of load on the anchor using a steel fitting (see Photograph 7).

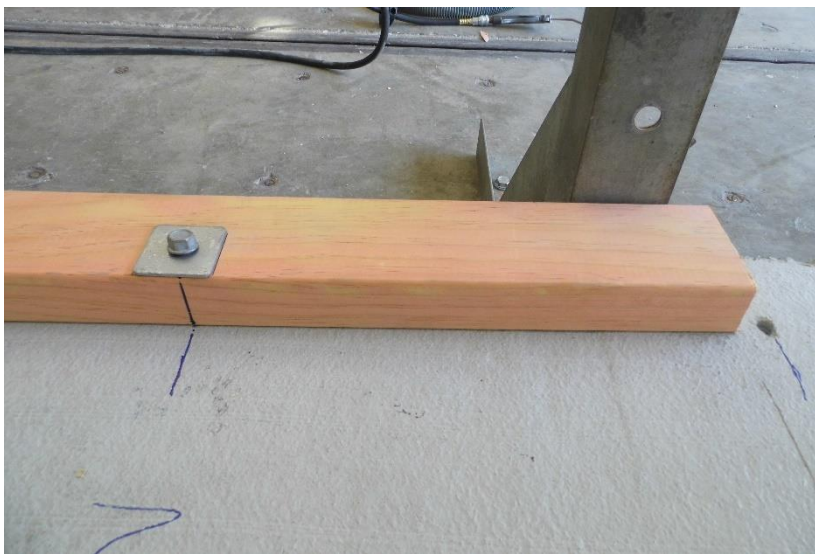
No failures were observed up to a maximum load of 3.6 kN, or 1.8 times the target load of NZS 3604.

Photograph 8. Undamaged in-plane test.

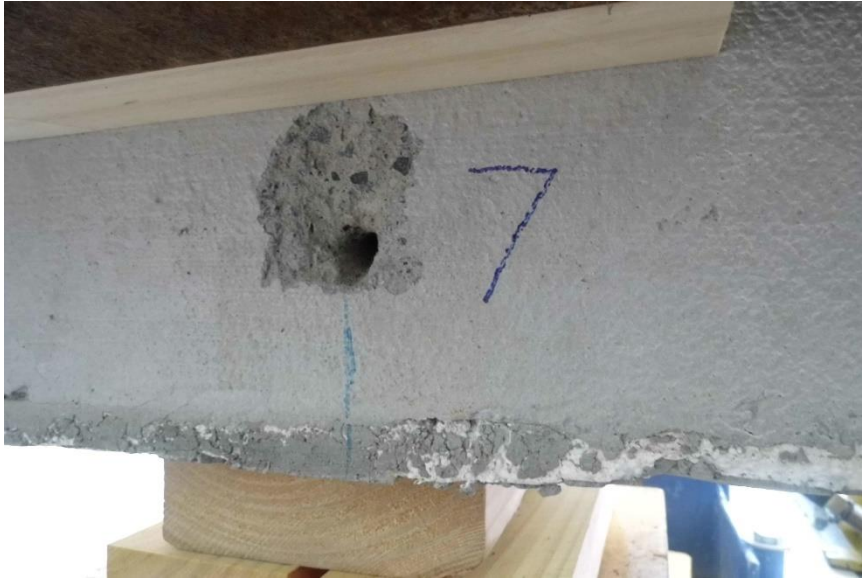
Photograph 10. Concrete cone failure under tension loading

The additional bracing hold-down tension tests were carried out to failure. Failure occurred either by concrete tension cone failure (Photograph 10), or edge breakout (Photograph 11).

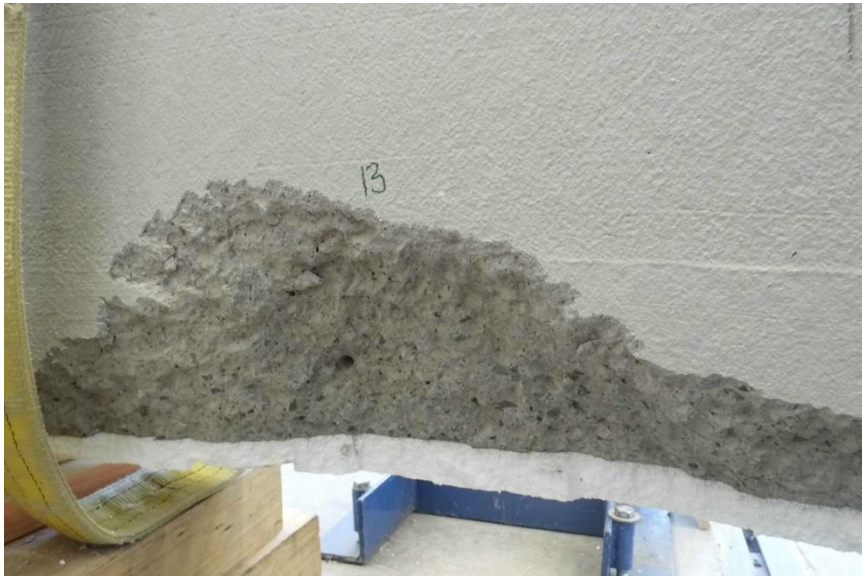
Photograph 11. Concrete edge breakout under tension loading.

Tests 7 to 11 were carried out on a slab that had not been previously used for testing. However due to extensive edge breakouts, tests 12 and 13 had to be carried out on a slab previously used for testing (although apparently undamaged). The two low results indicated this slab had been compromised by the previous tests, so the set of results was re-examined with these results ignored (third column of the table).

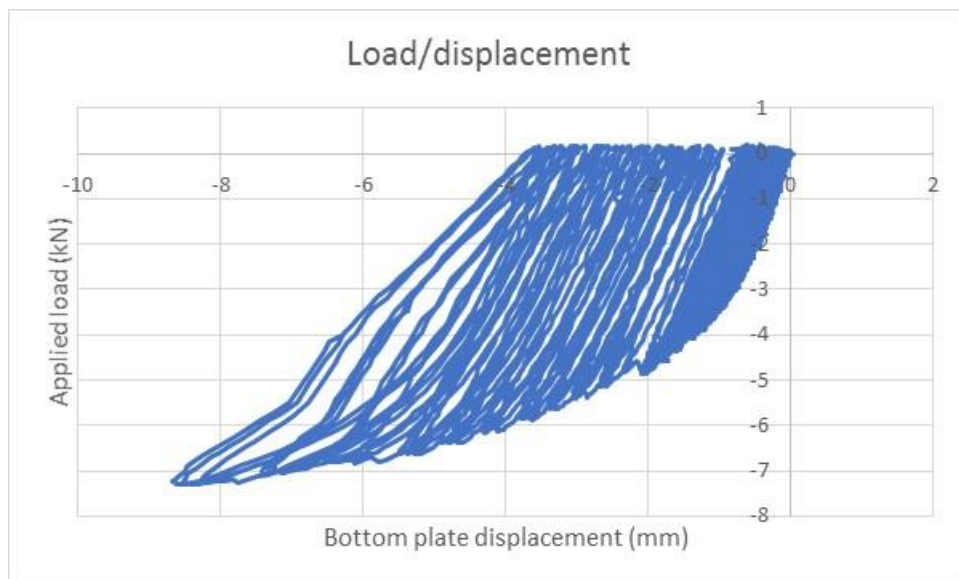
Figure 6. Out-of-plane loading direction.

All in-plane, uplift tension, and out-of-plane tests passed the required target loads of NZS 3604 without significant failure.

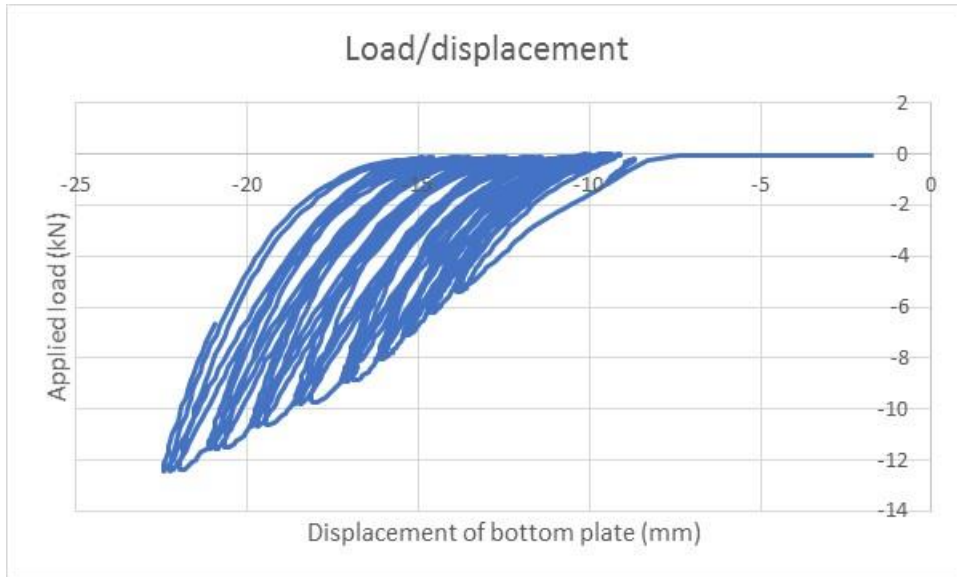
Figure 7. Tension loading direction.
